Coal Operators' Conference

2003

ROADWAY SPAN STABILITY IN THICK SEAM MINING - FIELD MONITORING AND NUMERICAL INVESTIGATION AT MORANBAH NORTH MINE

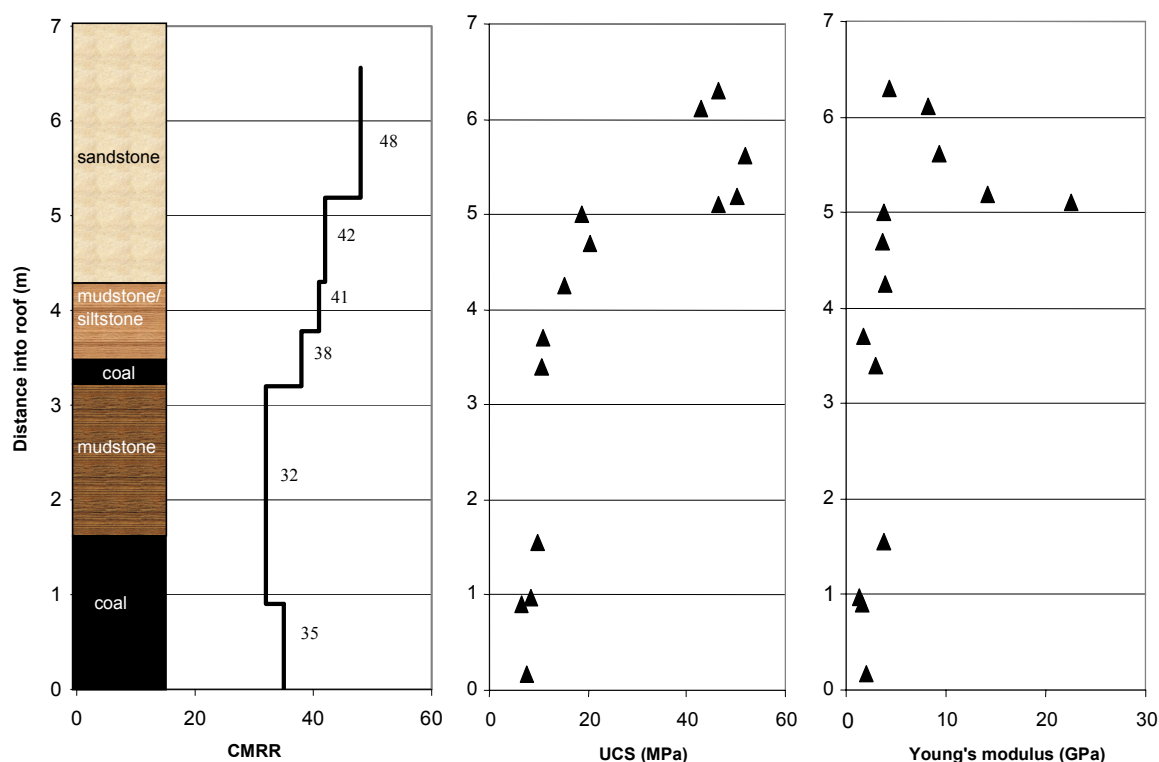
FIG. 1 - Roof geology, CMRR, rock strength and Young's modulus in the monitored holes

The geology from the drill holes is generally consistent. The typical roof geology in the monitored area is shown in Figure 1. The immediate roof is 1.7m coal. It is of C3 type (40-60% bright) immediately above the roof and becomes dull coal with bright bands at the top of the seam. Overlying the coal seam is a weak to very weak mudstone unit. The mudstone unit has a thickness of about 1.8m. Above this unit is the Goonyella Rider Seam (GMR) which has an average thickness of 0.2m. Above the GMR unit is a sequence of mudstone/siltstone/sandstone units.

Also shown in Figure 1 is the Coal Mine Roof Rating (CMRR) for different roof units. The roof coal and the mudstone units have a CMRR value ≤ 35 (Figure 1). According to Mark (1999), unsupported roadway spans with a CMRR less than 46 are considered to be unstable in the long term.

Fourteen coal and rock samples selected from the roof cores were tested in uniaxial compression to determine the strength and deformability (Cunnington and Boland, 2002). The tested Uniaxial Compressive Strength (UCS) and Young's modulus (E) are also plotted in Figure 1.

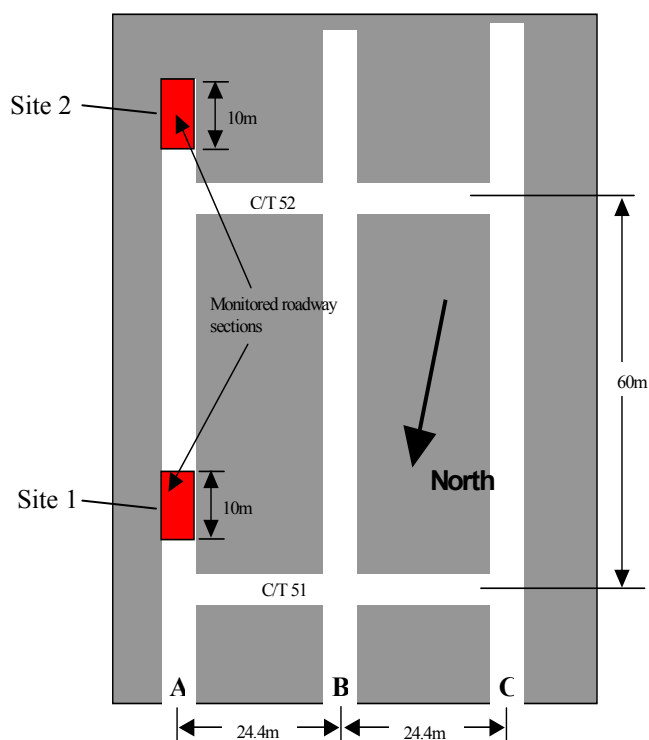
FIG. 2 - Mining layout and the monitored sections of the roadway heading A.

Two sections of Roadway A at LW 104 (Figure 2) were monitored in the vicinity of the 51 and 52 C/Ts where overburden depth is 220m. The monitoring program included three main components:

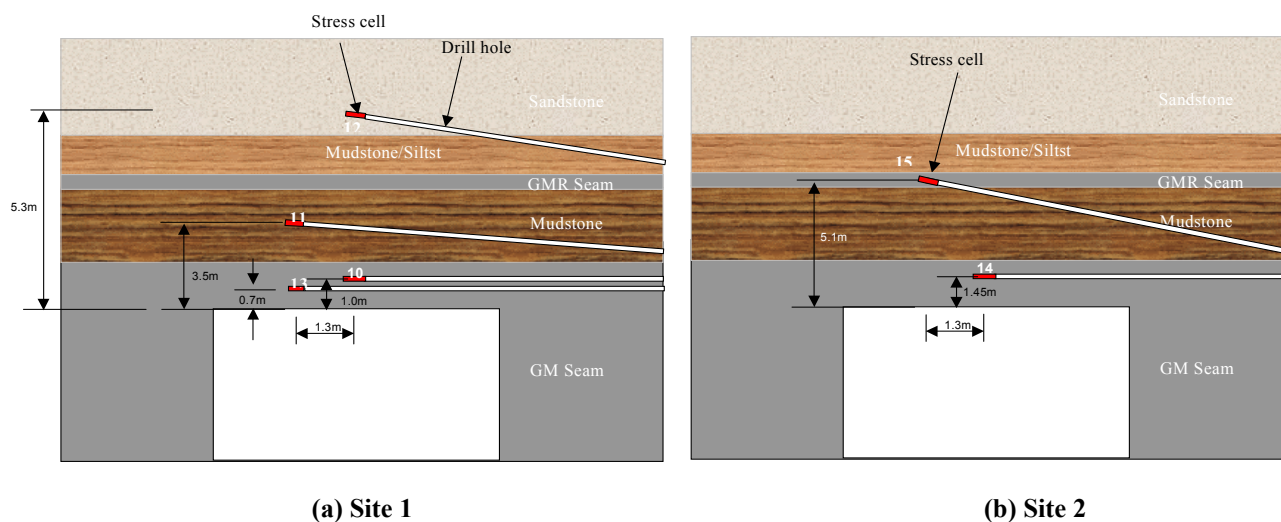
FIG. 3 - Location of stress cells in roof at the two monitoring sites

Four ANZI stress cells were installed at Site 1 and two at Site 2, see Figure 3. The stress cells were located in different roof units and they were installed in boreholes drilled from the cut-throughs prior to the excavation of the monitored roadway sections. Figure 4 shows one such arrangement. After the installation of the stress cells, the roadways were cut in the sequence marked in Figure 4 i.e. 1→2→3→4. The changes of the stresses in the roof were monitored with frequent data reading (every 30 minutes) when the monitored roadway sections were cut.

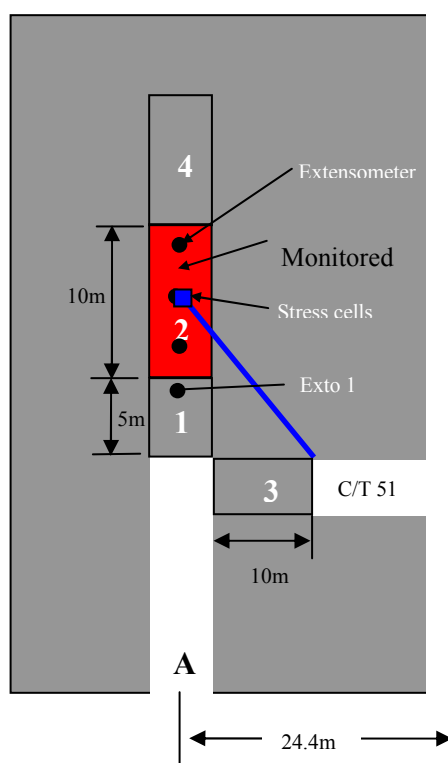
FIG. 4 - Drilling arrangement for stress cell installation and mining steps during monitoring.

Four sonic extensometers were installed in the monitored roadway roof immediately after roof bolting at each site. Displacement data were read as the roadway advanced. The maximum displacement was obtained at the monitored location closest to the cut-throughs (Extensometer 1 at Site 1, see Figure 4, and Extensometer 5 at Site 2). The two extensometers were installed close to the face of previous cut and therefore measured the full roof response to the roadway advance. Other extensometers were installed within the length of the full bolted roadways where much of roof displacement might have already occurred. They hence measured much less roof displacement. The monitored roof displacement from Extensometers 1 and 5 are shown in Figure 7.

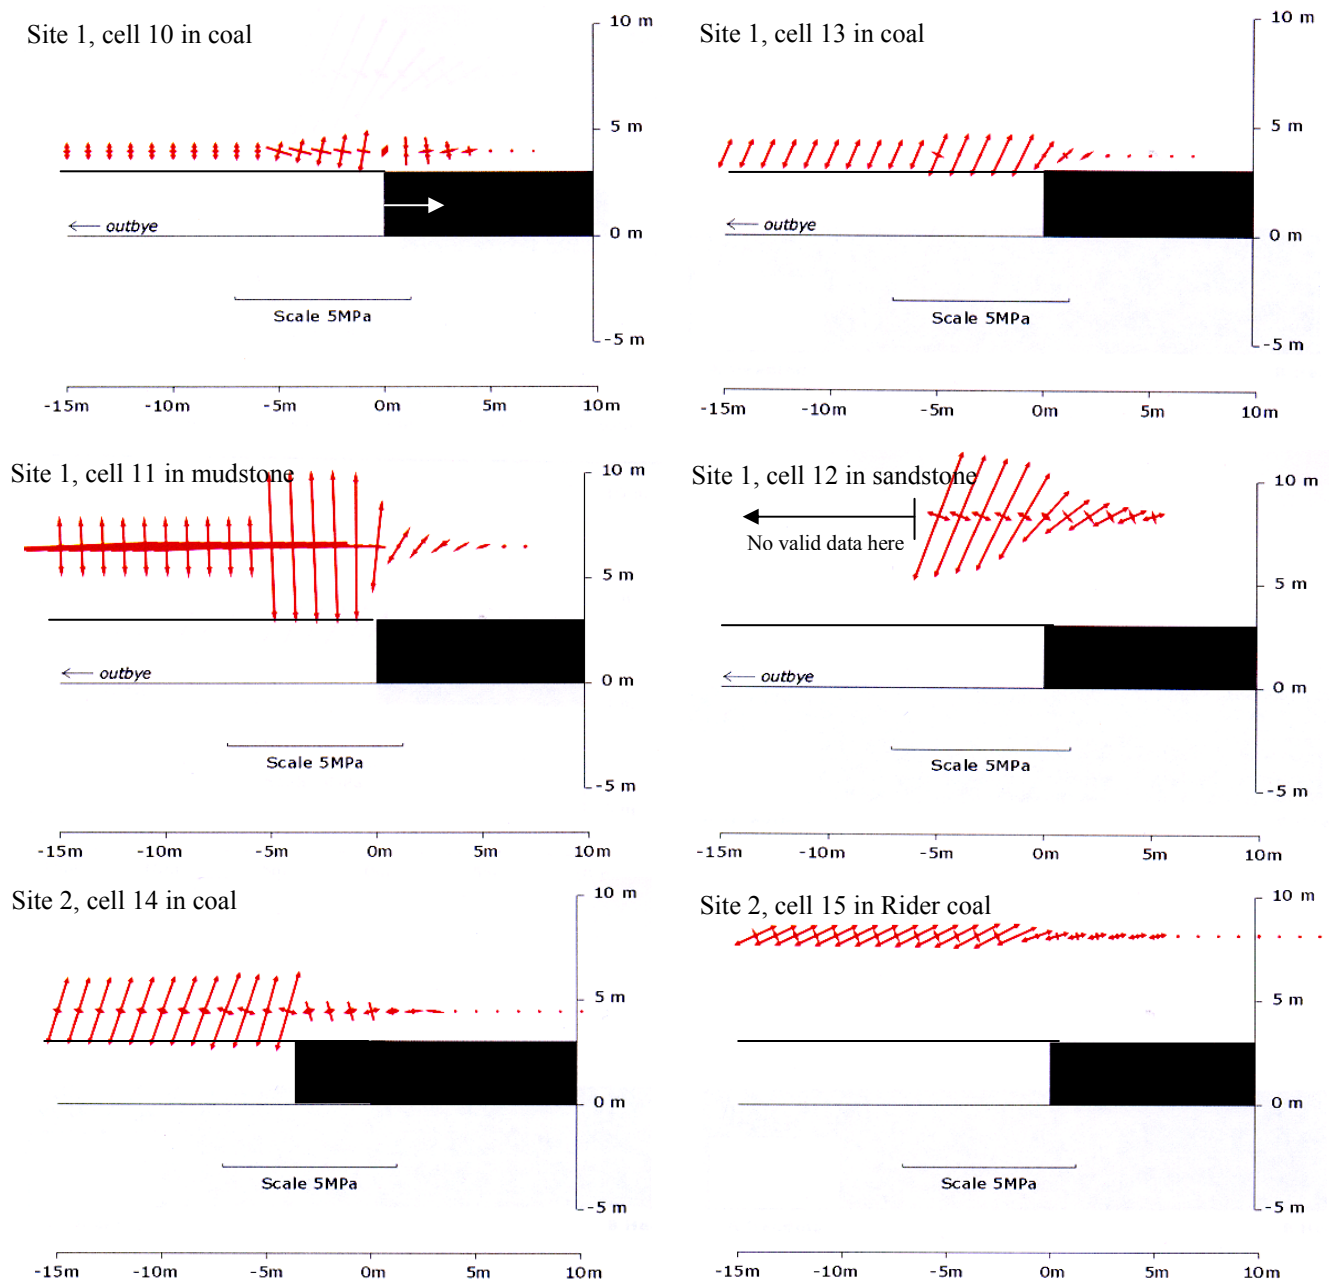
FIG. 5 - Monitored stress change in roof coal and rock units versus roadway face position in a vertical cross section parallel to the roadway axis. Outward arrow indicates reduction of compressive stresses

The measured stress changes in the roof coal, mudstone and sandstone during roadway advance are shown on a vertical section in Figure 5. The vertical stress change in the roof coal with time is shown in Figure 6

Stresses in the roof rotated when the roadway face approached and passed the monitored locations (FIG. 5). At Site 2, cell 15 in the Rider Seam indicated a change in level and orientation implying shearing along the Rider Seam. Vertical stress in the roof dropped sharply immediately after the roadway face passed the monitored locations (Figure 6).

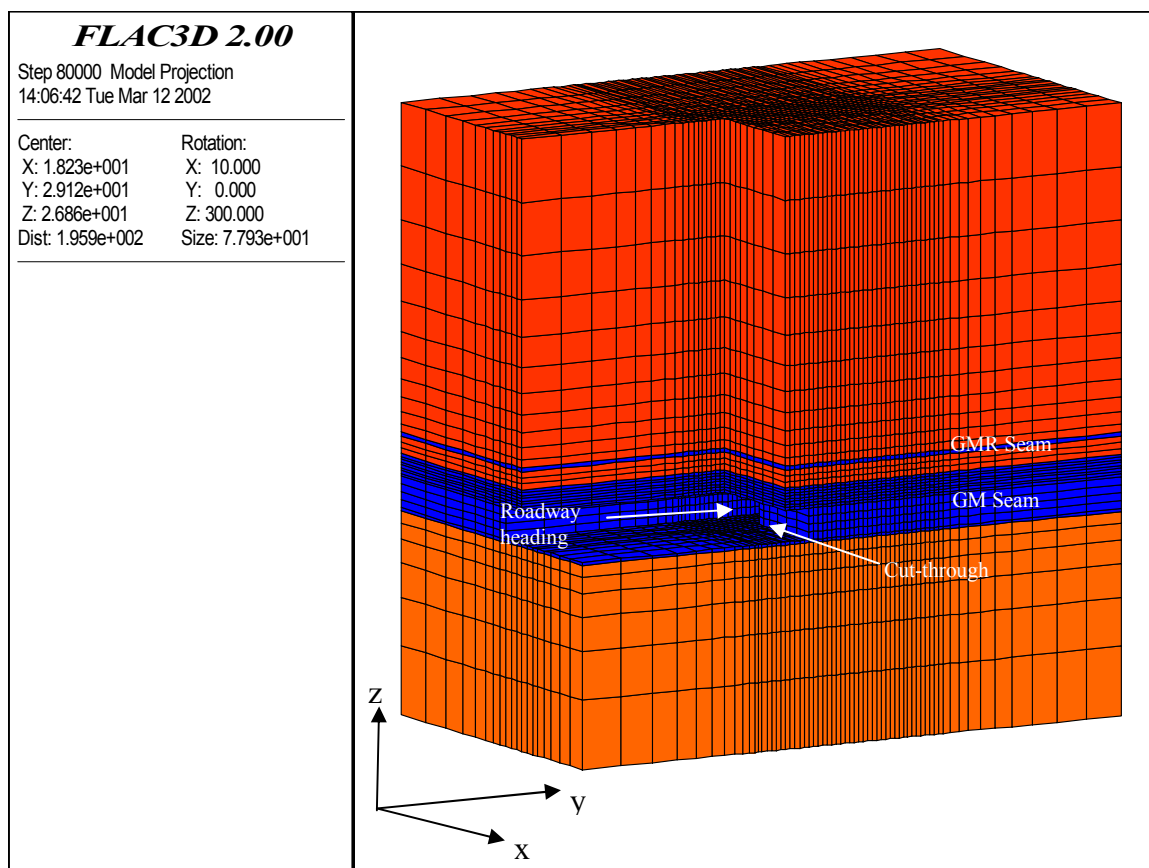
FIG. 8 - A 3D numerical model for roadway stability at Moranbah North

The three dimensional numerical simulation of the monitored roadway was conducted using FLAC^{3D} (Itasca, 1997). A 3D numerical model was set up based on the simplified geological log shown in FIG. 1. The true mining sequence, including roof and rib bolting, was simulated. The modelled stress change and displacements in the roof were investigated and compared with the measurements. The model geometry is shown in figure 8.

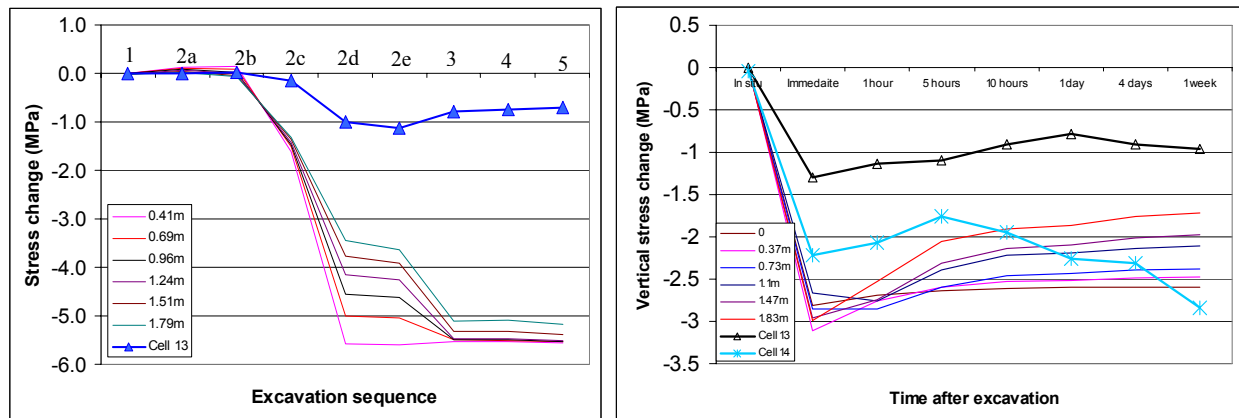
(a) 3D mechanical modelling results

(b) 2D coupled modelling results

FIG. 9 - Modelled vertical stress change (un-marked lines) in roadway roof at Site 1 in comparison with the measurements (marked lines). The modelled results are given at different distances into the roof. Excavation steps correspond to the roadway sections marked in Figure 4. Steps 2a-2d are excavations of the 10m section 2 with 2.5m increment, 2e is after roof bolting. Step 5 is further advance of the roadway.

Using the 3D model without considering gas/water pressure, the predicted change of vertical stress in the coal roof during roadway excavation was about 5.5MPa, much higher than measured (see Figure 9a). Unlike the measurements, the model predictions did not show any recovery of the vertical stress in the coal roof after the initial drop.

The 2D model simulated the gas/water pressure and fluid flow in the coal seam during the excavation process. Figure 10 shows the modelled pore pressure distribution 5 hours after roadway excavation. The predicted vertical stress change in the coal roof was in general agreement with the measurements (Figure 9b). The predicted maximum magnitude of the vertical stress change was 2.5-3.0MPa, closer to the measurements of 1.3MPa at Site 1. More importantly, the modelling results showed a clear stress recovery after the initial stress drop, consistent with the measurements.

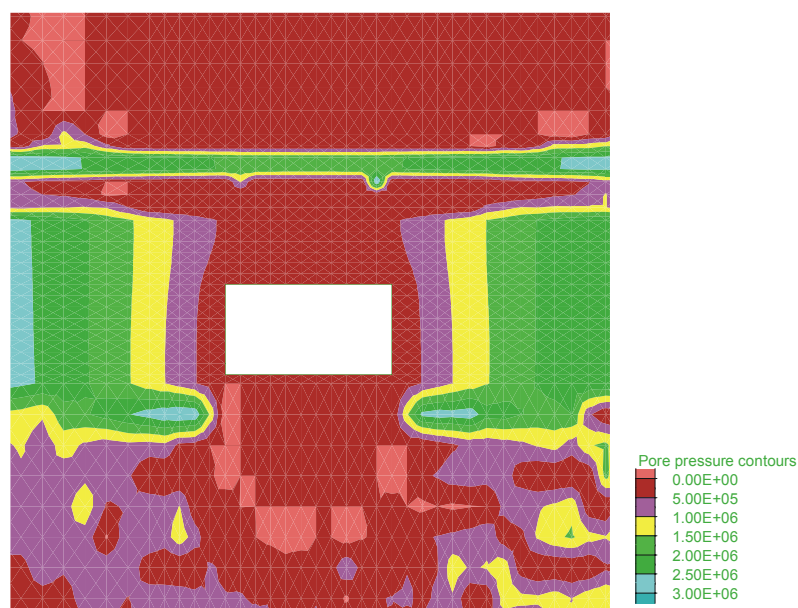
FIG. 10 - Pore pressure distribution around roadway, 5 hours after excavation

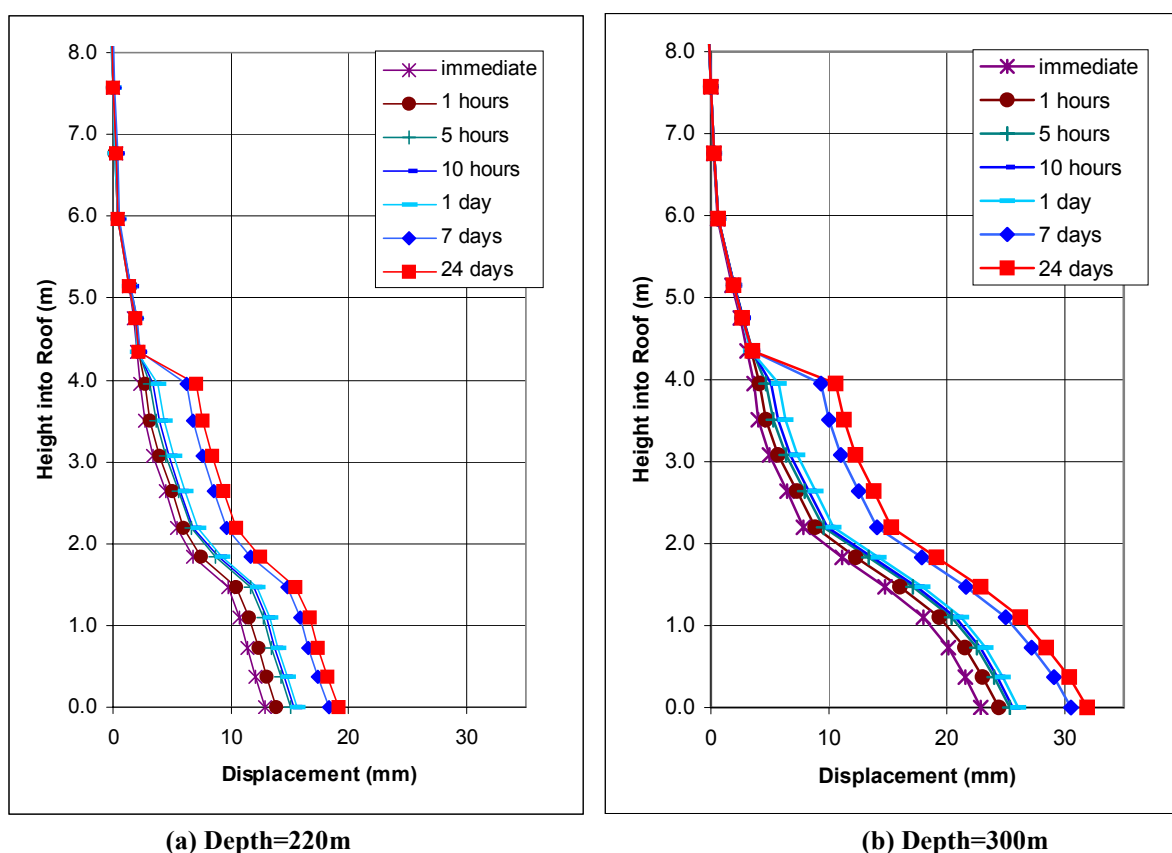
FIG. 11 - Modelled roof displacements at two different depths. The time dependency is caused by fluid flow in the coal seam after roadway excavation.

Additional modelling was conducted using the 2D coupled mechanical-fluid flow model at different depths. The modelled roof displacement at two depths (220m and 300m) are plotted and compared in FIG. 11. The case of increased depth will also be relevant to the Site 2 condition where higher *in situ* stress existed, equivalent to a deeper location.

At the current depth of 220m where the measurements were conducted, the predicted maximum roof displacement is 19 mm. The predicted roof displacement is in a close agreement with the measurements from roof Extensometers 1 (FIG. 7a). The model predictions also show a clear time variation due to the fluid flow after excavation.

At the depth of 300m, the predicted maximum roof displacement is 32mm, significantly higher than that at the depth of 220m.
